**LOWER THAMES RIVER BASIN
NORWICH, CONNECTICUT**

**TRADING COVE POND DAM
CT 00237**

**PHASE 1 INSPECTION REPORT
NATIONAL DAM INSPECTION PROGRAM**

JUNE 1981

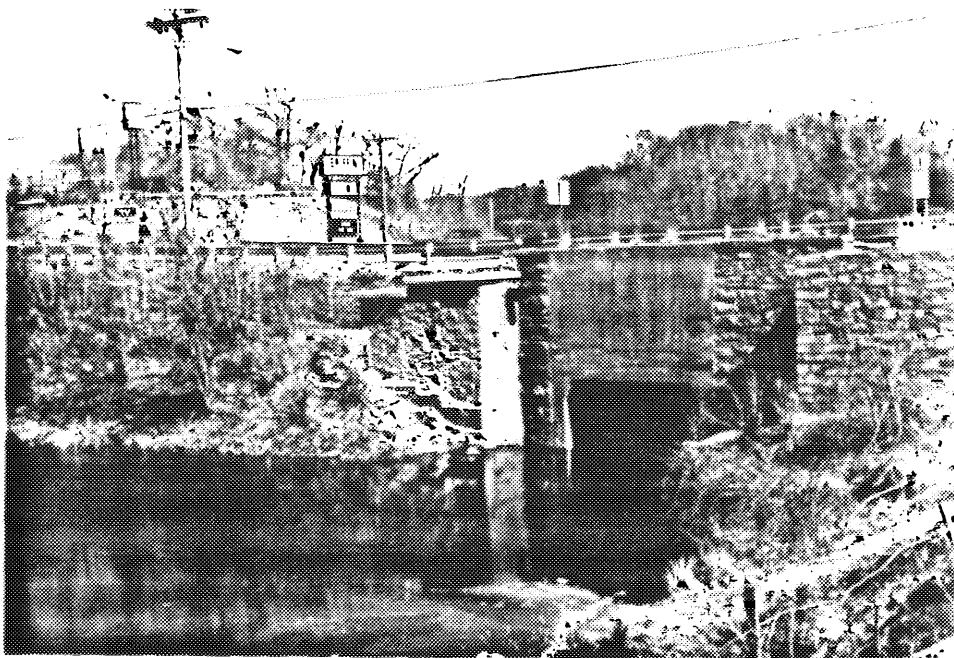
2. Upstream Slope: The upstream slope of the dam consists of an ashlar masonry wall near the crest and an earth embankment on the lower part of the slope (see Photo 1). Part of the wall on the left side of the spillway has been gunited. Some of the gunited areas near the spillway have begun to show signs of spalling, as seen in Photo 1. To the right of the spillway there are areas which have mortar missing from between the stone blocks. Earth fill has been placed against the lower part of this wall, but the fill has a very irregular surface and an extensive growth of small trees. The retaining wall just to the left of the spillway has also been gunited and has had PVC drain pipes installed about 2 to 3 feet into it.

Photo 1. Upstream view of the dam from parking lot at edge of pond. Note cement bag retaining wall at left end of culvert embankment.

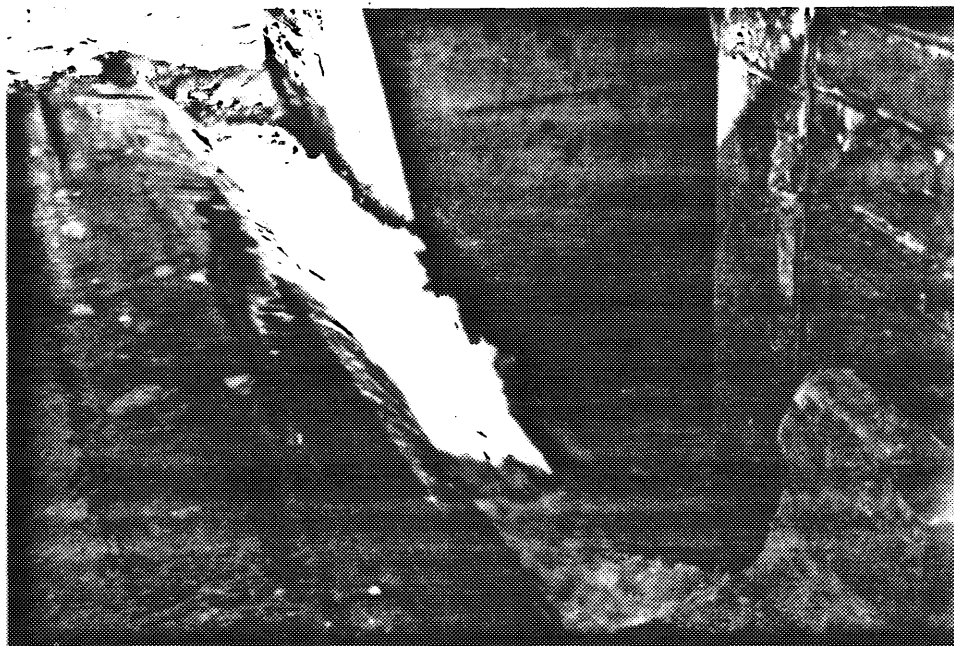
1. Spillway: The spillway consists of an ashlar masonry structure with flashboards (Photo 2) and training walls on both sides (Photo 1). The spillway discharge channel passes through the dam. The upstream and downstream sections of the channel are a concrete box structure, while the central section has ashlar masonry walls and a concrete slab roof (Photo 6). There are drain holes in the downstream section of the channel and both the concrete and ashlar masonry appear in good condition. There was no flow observed coming out of the drain holes along the masonry or concrete walls. Minor efflorescence and evidence of seepage were observed on the masonry walls.

Photo 2. Spillway weir and flashboard at inlet of culvert.

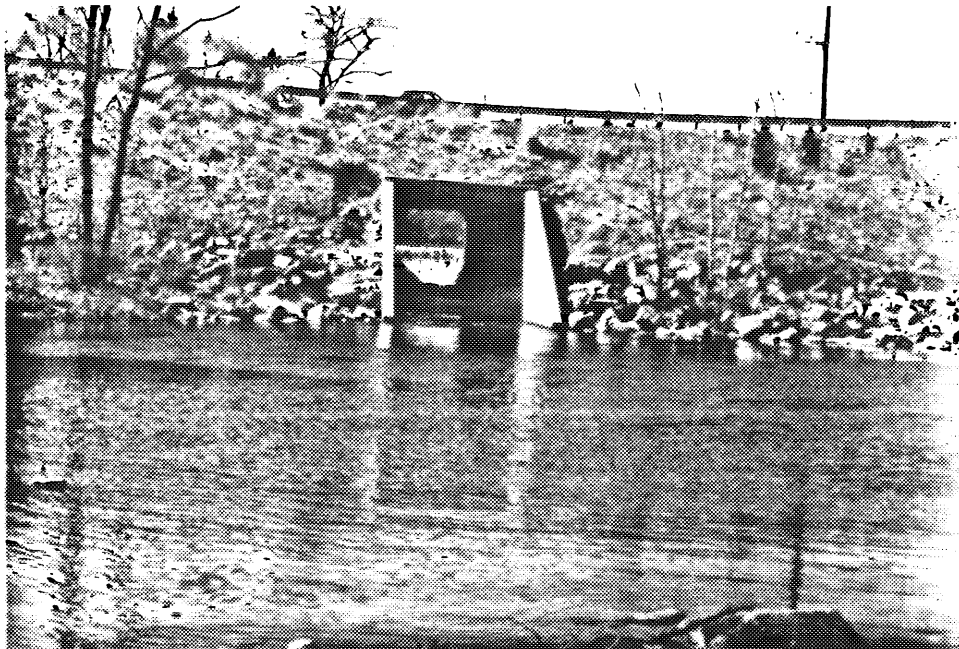
grass slope with some brush and small trees (up to a trunk diameter of 3 inches) growing on it (Photo 3). There are some footpaths along the slope which have resulted in erosion, particularly near the wing walls of the outlet channel to the spillway, as seen in Photos 3 and 4. The erosion here is as deep as 2 feet along the right side of the structure. No seepage or sloughing of the embankment was observed along any of the downstream areas. The lower part of the slope is protected against tail water erosion by riprap which extends about 10 feet up the slope in the vicinity of the wing walls of the outlet structure.

Photo 3. View of downstream slope of dam and spillway weir on upstream side (as viewed through the culvert). Note erosion along both wing walls of culvert outlet.

1. Repair the erosion adjacent to the wingwalls of the culvert on the downstream slope of the dam with crushed stone.
2. Remove small trees and brush growing on the slopes and within 20 feet of the toe, and develop protection against erosion with grass or riprap.
3. Regrout the upstream ashlar masonry wall and repair the gunited section.
4. Reinstall the trash rack removed from the outlet works and clean the general area around it.
5. Establish a program of annual technical inspections by a registered professional engineer.
6. Implement and intensify a program of diligent and periodic maintenance including, but not limited to, mowing brush on slopes, backfilling animal burrows with suitable well tamped material, and cleaning debris from spillway and slopes.

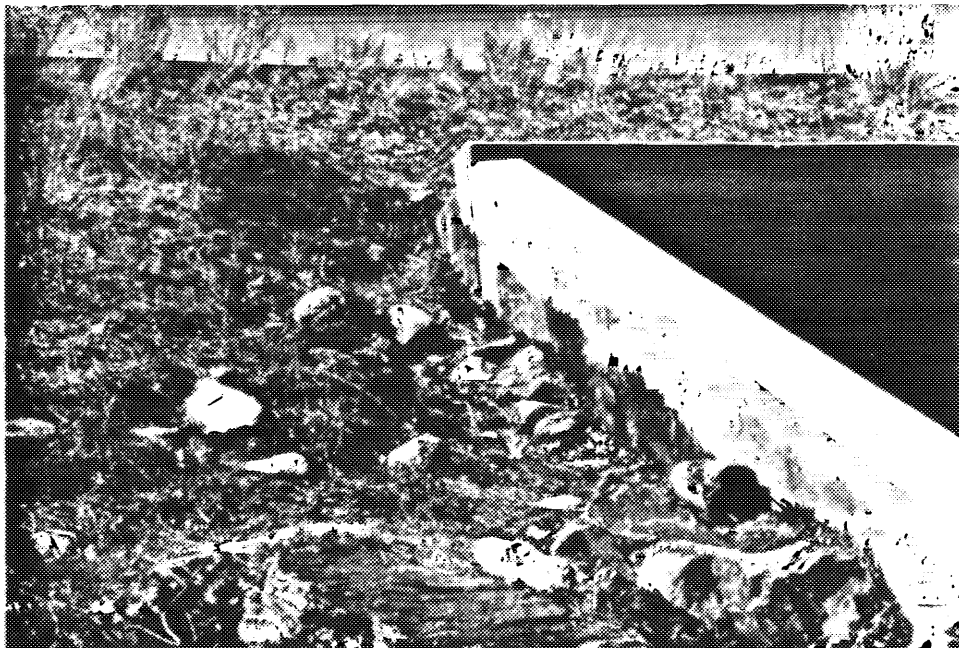
Photo 4. Closeup of erosion along the right wing wall of the culvert outlet.

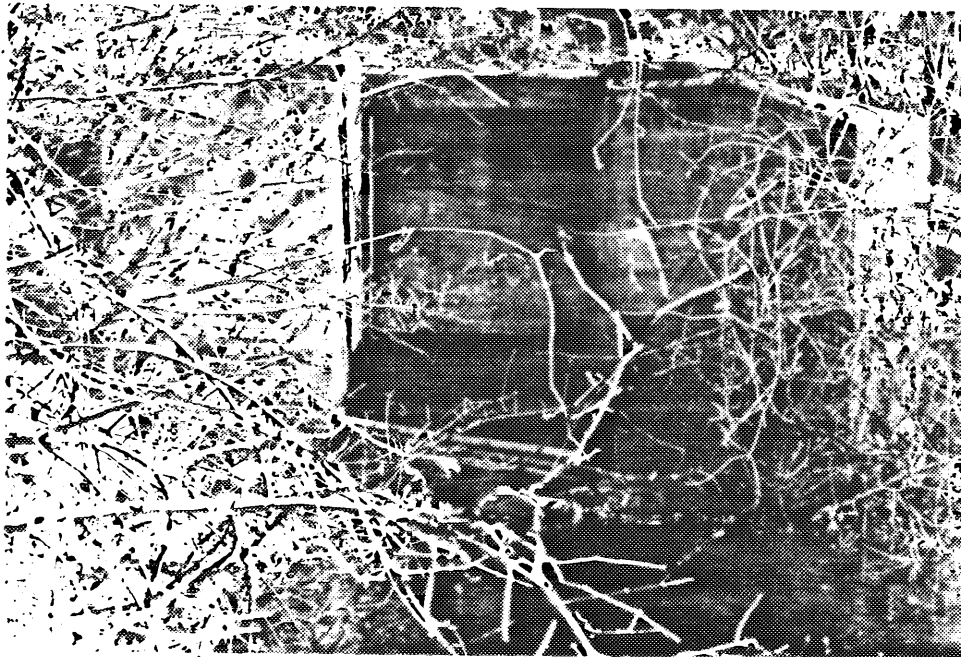
2. Outlet Structure and Tail Race Channel: The intake is located near the left abutment. The concrete is in good condition (Photo 5), but there is no gate, and the trash rack has been removed and lies at the bottom of the entrance channel. The conduit through the dam is, at its upstream end, a concrete box (Photo 5). The conduit then turns to the left at a right angle. The nature of the channel from this point could not be observed or otherwise determined. At the downstream side of the dam, the conduit could not be observed, because it was covered with stones. The water flows up through the stones (photo 7), and then continues into a tail race channel. The tail race channel has a natural earth embankment on its left side and a concrete wall on its right. The right side of

Photo 5. Intake structure near left abutment of dam.
Note trash rack tilted towards the pond.

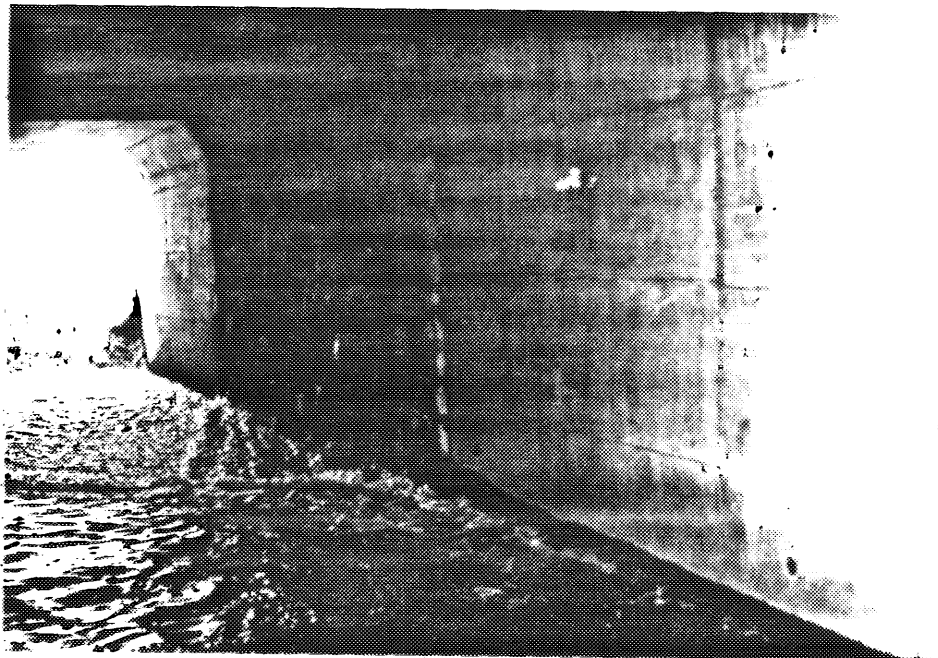
Photo 6. Spillway channel (culvert) through dam as
seen from downstream end. Note stone masonry
center portion of spillway channel, which
probably indicates the size of the original dam.

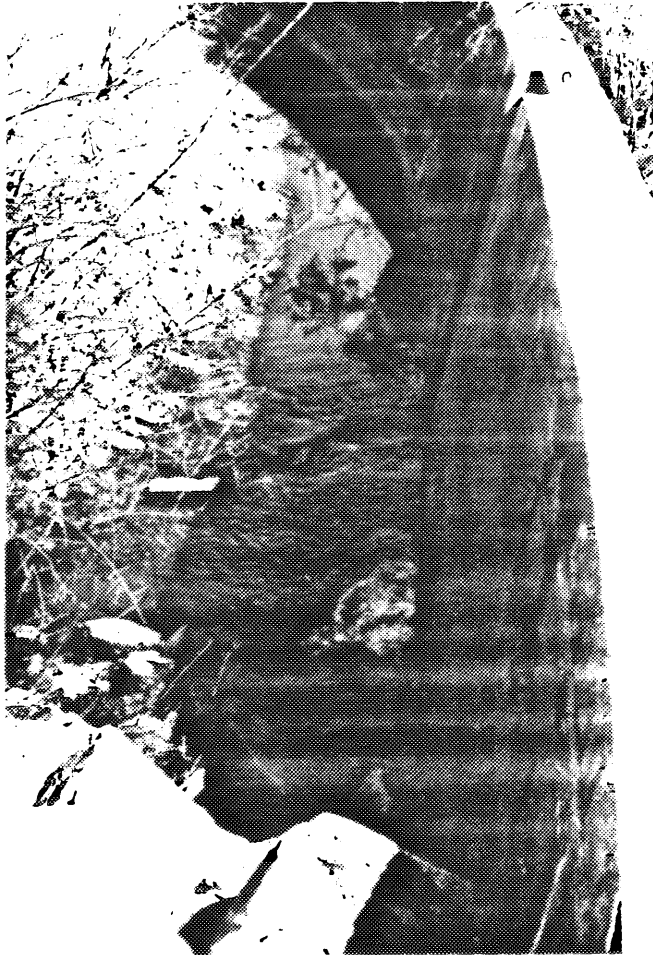
Photo 7.

this wall has an earth embankment placed against it as shown on Photos 7 and 8. About 20 feet downstream of the conduit outlet, there is a pipe with the gate removed that conveys the flow to the downstream spillway channel (Photos 7 and 8). The concrete wall of the tail race channel is cracked and shows displacements across the cracks of up to about one inch (Photo 8). The earth embankment behind the wall is overgrown with brush and has an irregular surface (Photo 8).

Tailrace channel for conduit passing through dam. Outlet is buried beneath the stones in the foreground. Note gate slot for discharge pipe from channel into main stream at right of photo on retaining wall.

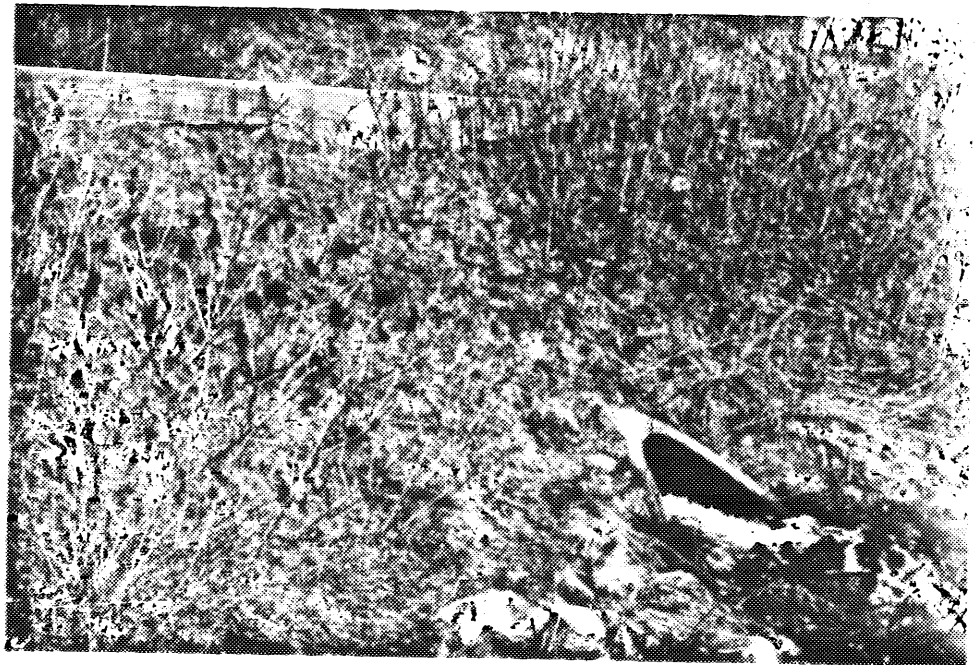
Photo 8.

Downstream side of discharge pipe from tailrace channel. Note spalling of concrete wall.

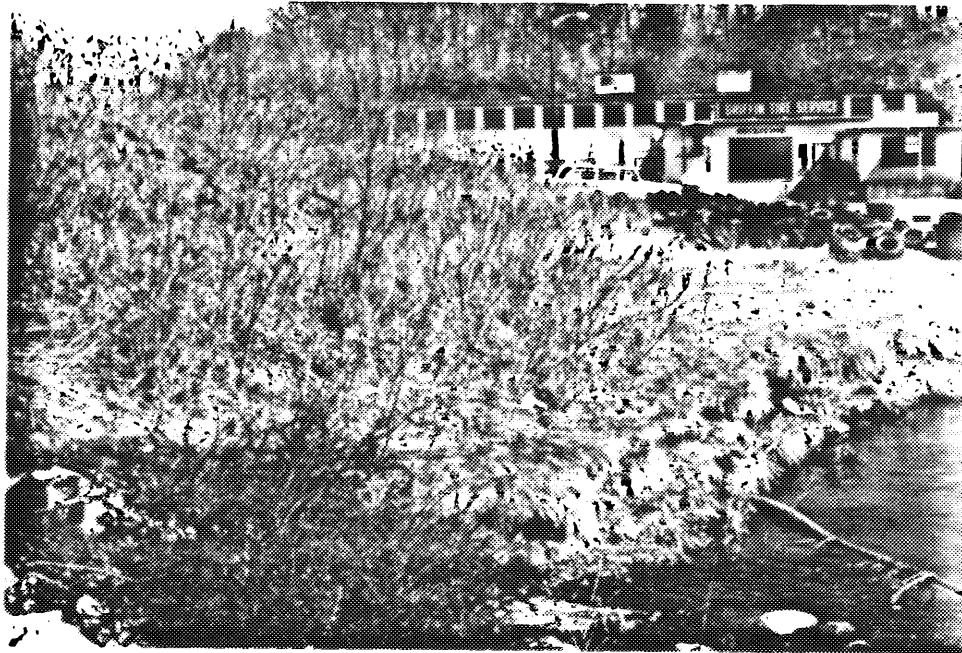
Photo 9. Downstream view of Griffin Tire Co.
from toe of dam.
